17203

Eardisland Village Hall at  
Eardisland, Herefordshire.

For Eardisland Parish Council.

## **STRUCTURAL CONDITION REPORT**

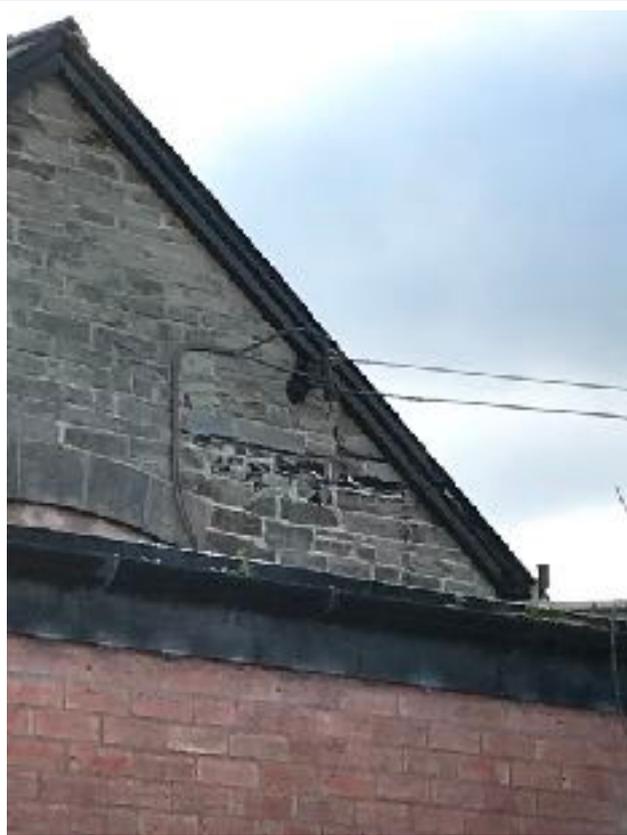
fig.1

- 3.1.1. A large void was noted adjacent to the end of the exposed upper slope purlin to the west roof pitch (see figure 1).

3.1.1 A large void was noted adjacent to the end of the exposed upper slope purlin to the west roof pitch

- 5.1.4. Stitch open crack to east elevation chimney.
- 5.1.5. Fill deep voids within external north elevation, using reclaimed stonework where possible.

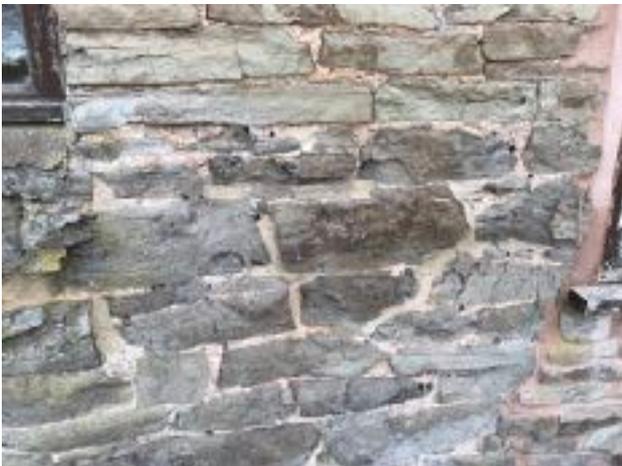
fig.2

3.2.1 Evidence of masonry bee damage to either side of the right hand large window opening.

- 5.1.6. Rake out and repoint areas of masonry bee damaged to east elevation.
- 5.1.7. Areas of deep re-pointing are required throughout the elevations, these areas should be raked out to a depth of 40mm and re-pointed with a natural hydraulic lime such as NHL 3.5.

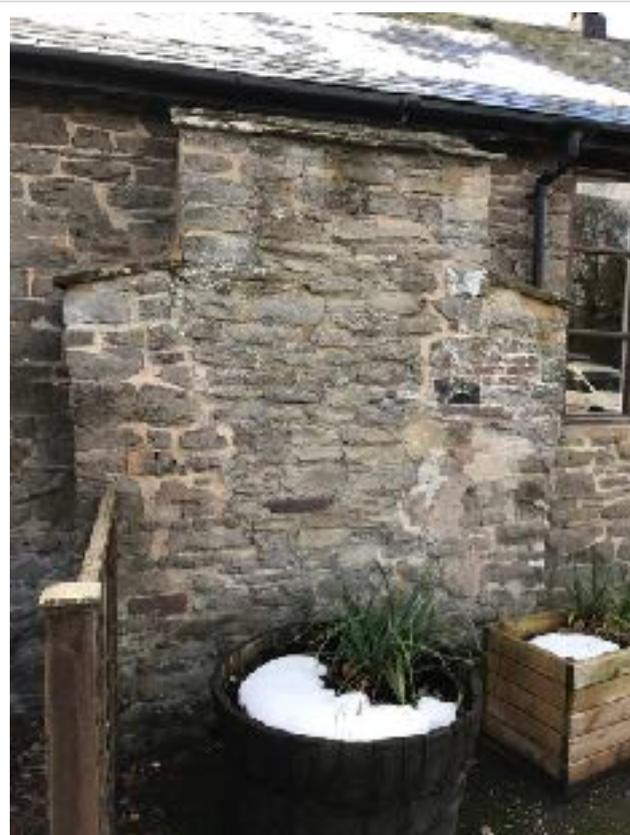
fig.3

3.2.2 A vertical crack was noted in the masonry facing work of the original chimney stack with evidence of considerable historical repointing

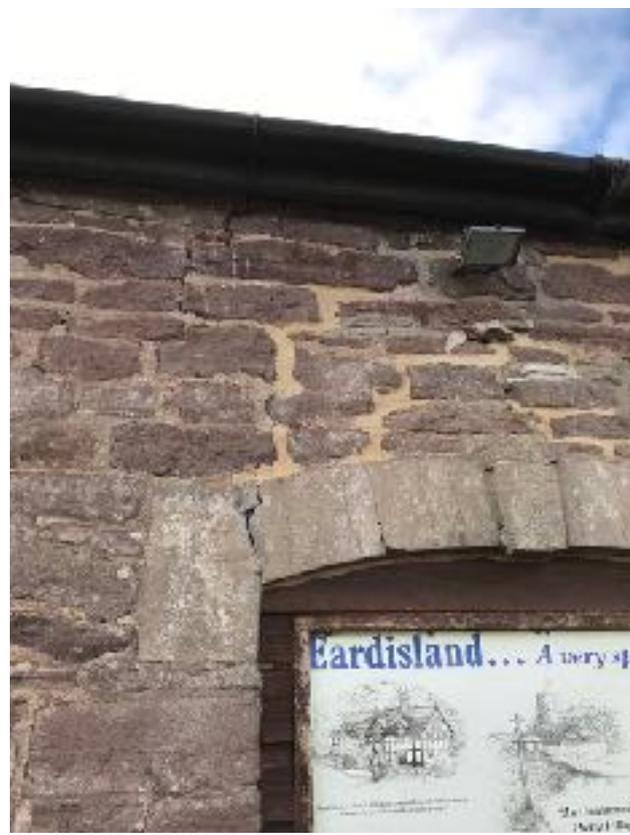
fig.4

3.2.3 Diagonal crack over entrance hall doorway (no infilled as sign).

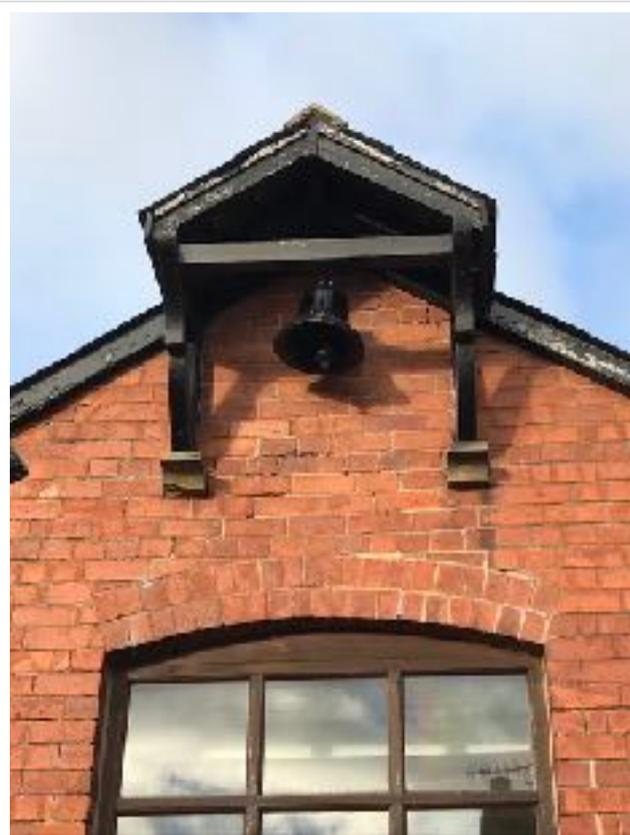
fig.5

3.3.1 Open pointing to the brickwork within the bellcote canopy and beneath.

3.3.2 Thick historical reporting to the arch construction over main window.

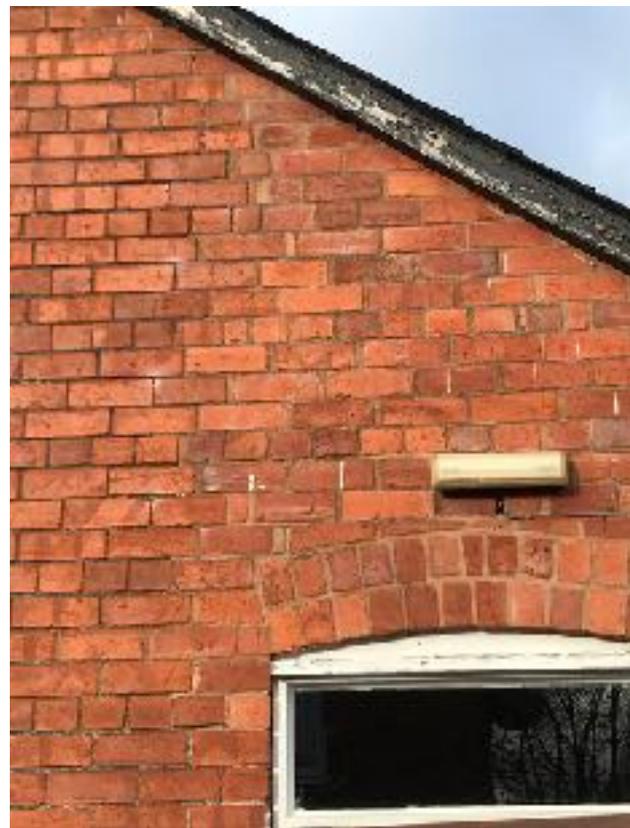
fig.6

3.3.3 Vertical cracking through brickwork masonry to the left of the door opening

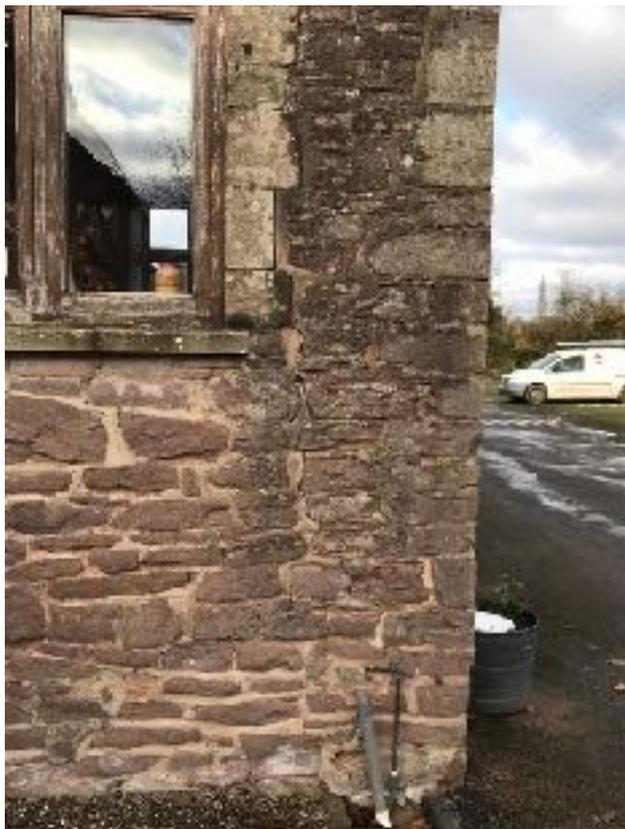
fig.7

- 4.1.9. The vertical cracking between the main hall building and the original entrance hall masonry is simply a result of the added walls not being sufficiently bonded into or tied to the existing when constructed. The historical thermal movements of the added masonry has caused this joint to open further and become filled with debris and therefore not closing. There does not appear to be any significant evidence of vertical movement of foundation settlement.

3.3.5 Open vertical cracking to the right of the window opening to the entrance hall south elevation.

- 4.1.10. These joints may be stitched with some resin fixed light stainless steel spire tie fixings and the joint repointed.
- 4.1.11. A similar form of stitching can be employed around the south elevation window of the entrance hall where the joints between keystone and adjacent voussoirs have opened.

- 5.1.2. Stitch vertical joints between entrance hall walls and main hall building.
- 5.1.3. Stitch open joints around south elevation entrance hall window opening.

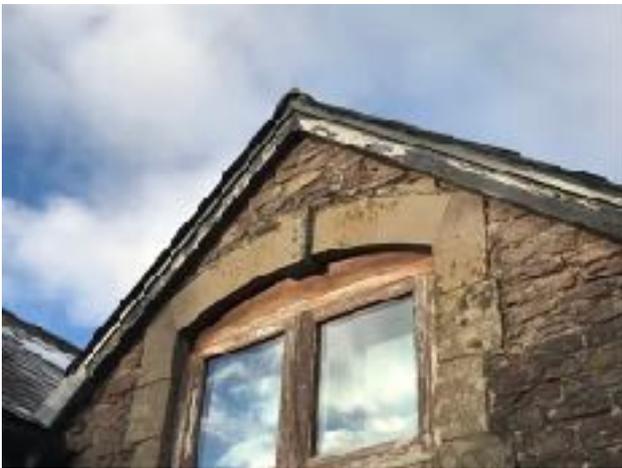
fig.8

3.3.6 Loss of pointing to the keystone to window arched head

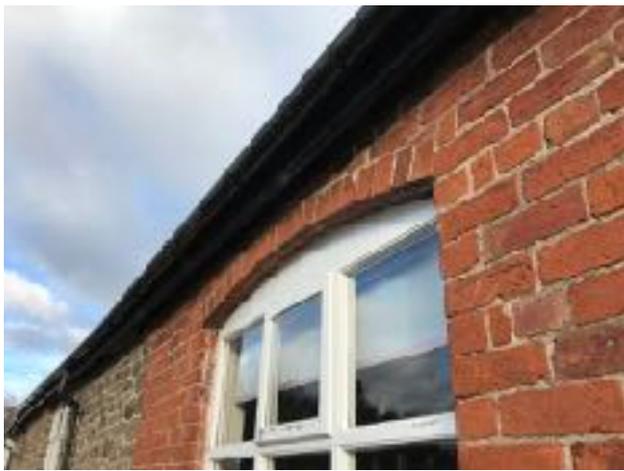
fig.9

3.4.1 Notable outward movement of brickwork masonry over the arch of the right hand window opening

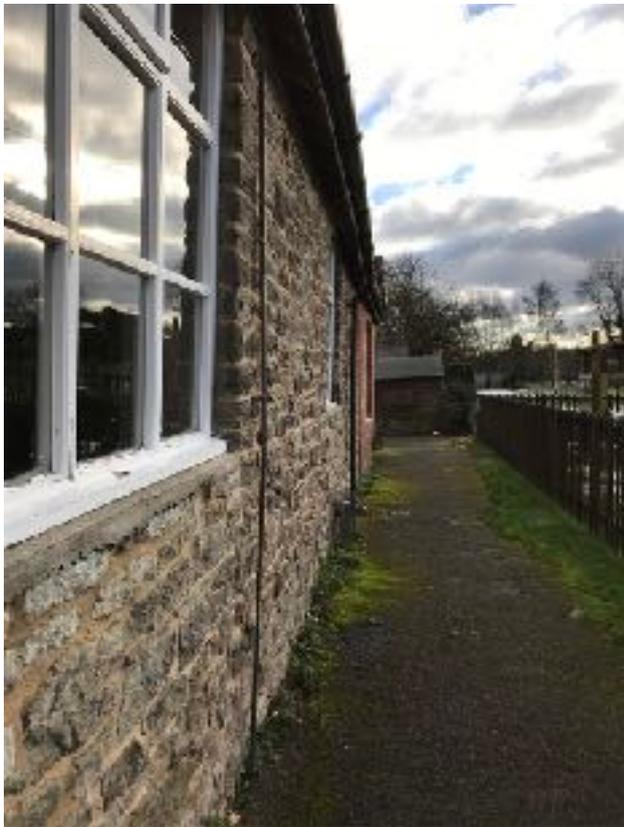
fig.10

- 4.1.2. The diagonal cracking noted to the main hall ceiling and the reveal of the east window are all a result of the movement that has occurred in the west elevation. The historical movement is considerable and a direct consequence of semi vaulted truss configuration of the scissor trusses that form the roof structure.

- 4.1.5. The effect of this horizontal spread of the roof trusses is to push outward at the head of the flanking walls, in this case the east and west elevations. If, however, one of these elevations is more heavy buttressed, such as is the case with the east elevation of the village hall due to the presence of the chimney, the lateral thrust will be applied to the side with less resistance. The west elevation appears to have taken the majority of the lateral thrust from the roof.

- 4.1.7. It would seem apparent that some movement is still occurring periodically given the disturbance noted beneath the most recent redecorations and the degree to which the inner face of the west elevation is out of plumb is considerable. However, given the basic measurements taken on site it appears that the walls

mass is still being applied within its middle third of its base width, which indicates the wall remains stable at present.

3.4.2 West elevation noted as leaning outward at its eaves level compared to wall base, at its maximum between main pair of window openings.

- 4.1.8. It would be of benefit during any future roofing works to consider the connection between the roof and the wall head at close hand and perhaps improve its effectiveness through a process of fixing the wall plates down to the underlying masonry.

- 5.1.1. Investigate at close hand the connection between roof and wall heads during next programmed roofing repairs/works and implement improved wall plate fixing detail.

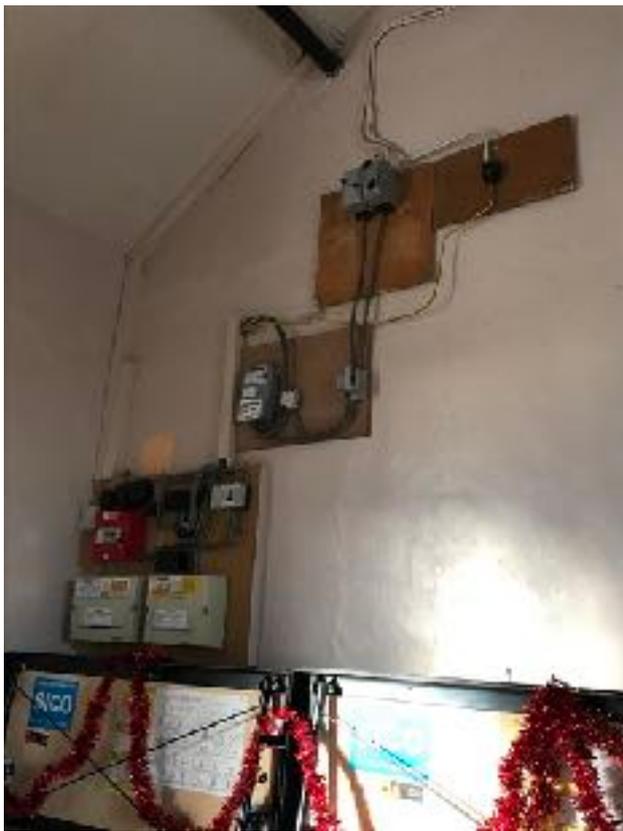
fig.11

3.5.1 Vertical cracking was noted inside the north elevation corresponding to the reveal of the infilled window opening.

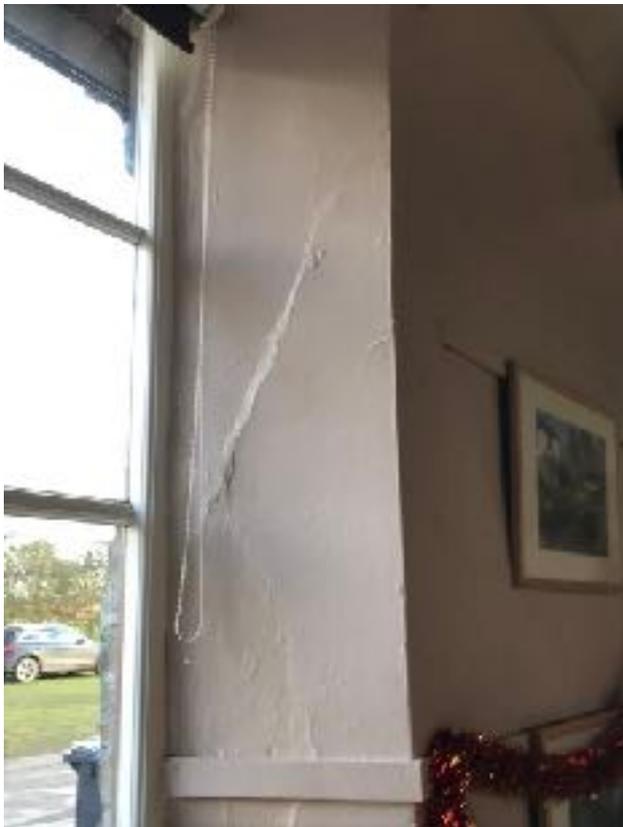
fig.12

3.5.3 Diagonal cracking noted to the reveal of the left hand internal window opening long the internal east elevation.

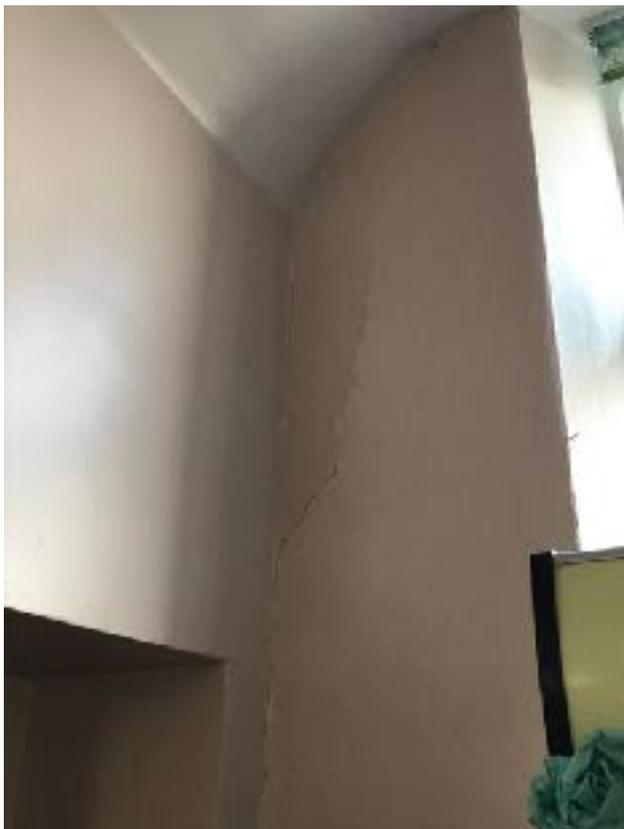
fig.13

3.6.1 Vertical cracking noted between the north wall and the west wall of the main hall.

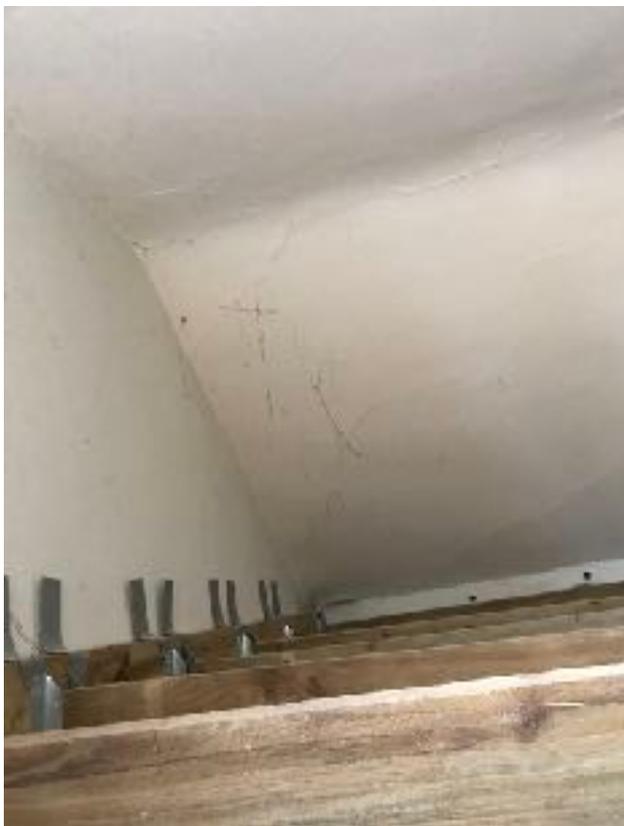
fig.14

3.7.1 Historical cracking to the semi vaulted ceiling construction above the modern plasterboard suspended ceiling
