17203

Eardisland Village Hall at  
Eardisland, Herefordshire.

For Eardisland Parish Council.

## **STRUCTURAL CONDITION REPORT**

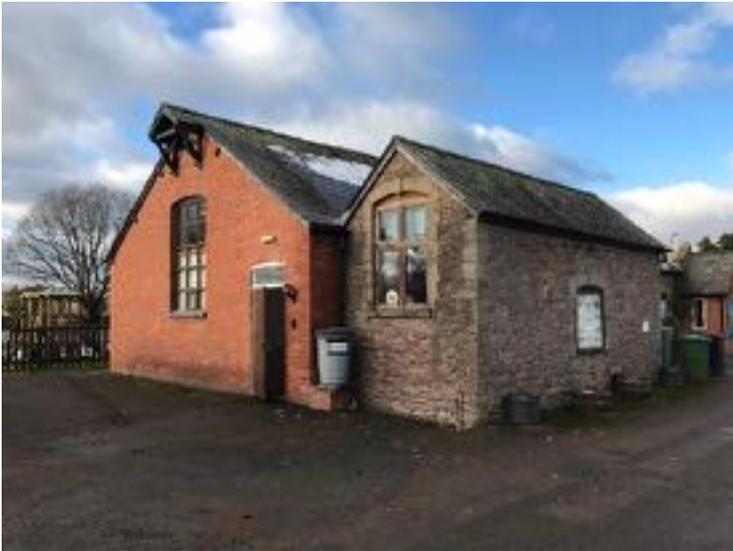
- 3.1.1. A large void was noted adjacent to the end of the exposed upper slope purlin to the west roof pitch (see figure 1).

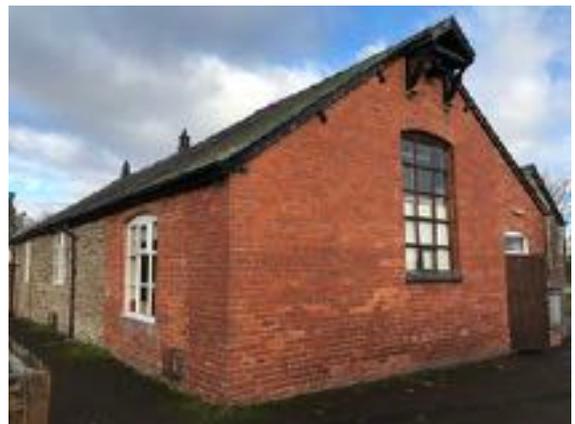
- 3.2.1. Evidence of masonry bee damage to either side of the right hand large window opening (see figure 2).
- 3.2.2. A vertical crack was noted in the masonry facing work of the original chimney stack with evidence of considerable historical repointing (see figure 3).
- 3.2.3. Diagonal crack over entrance hall doorway (no infilled as sign) (see figure 4).
- 3.2.4. Cracking through voussoirs of opening arch.
